No 6 Cement Mill Gearbox Input Pinion Bearing. Failure Analysis 2nd June 2006.

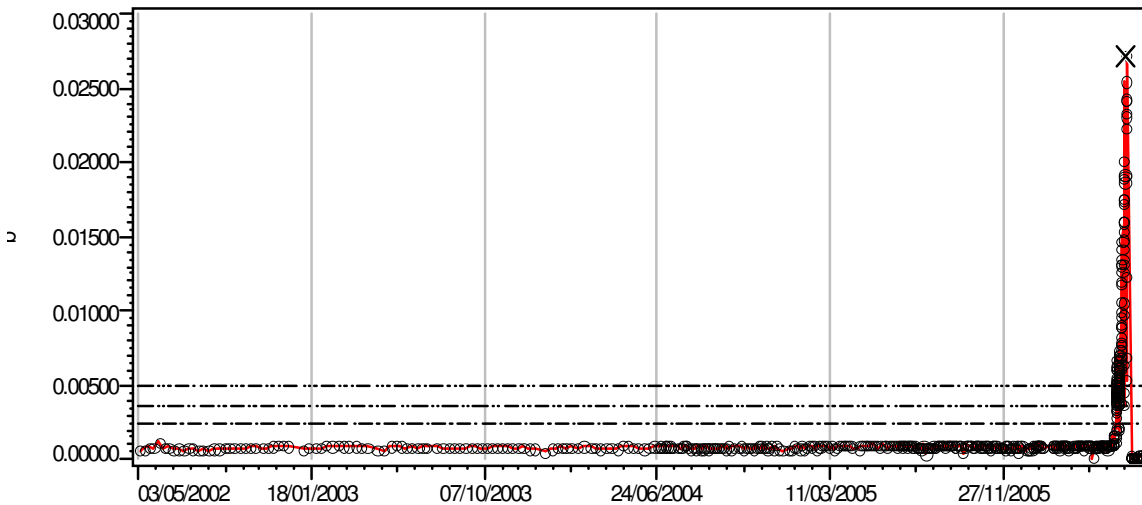
No 6 CEMENT MILL INPUT SHAFT Horizontal TREND.

Due to constant Predictive Condition Monitoring via an online Vibration Analysis program(MTC), the Maintenance department were able to detect a rise in trend on the Drive End of the Gearbox. As shown in the Trend below the gearbox had been stable for whole duration of the monitoring system (since May 2002).

So this sudden increase in Trend was of great concern.

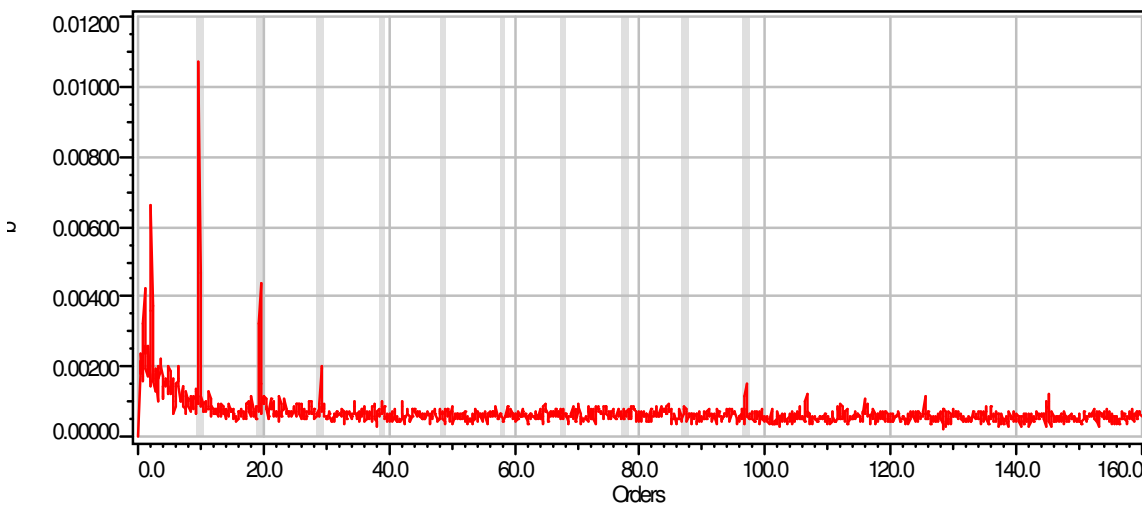
BPFO – 24148 C HFE Spectrum 2000Hz.

After several Fault Frequency calculations it was decided that the problem was on Input shaft Drive End bearing (SKF 24148C). As can be seen below the Frequencies match perfectly. The amplitude of the problem had increased by 22X in HFE range.

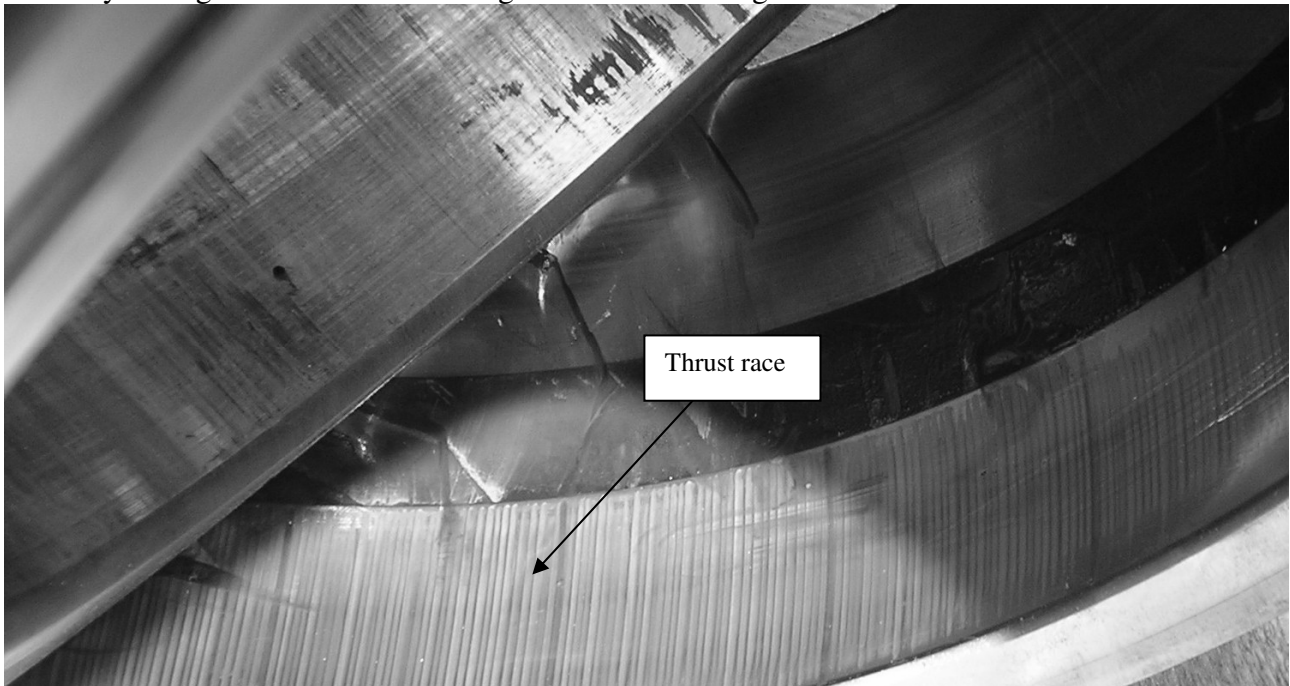
When the Input assembly was stripped out it was found that the Bearing had undergone 'Electrical Washboard failure'. This meant that electrical current was tracking through from the motor via the coupling (which is a steel pin type coupling) to the first bearing in the Input housing which is a Thrust bearing.

The only damage was on the 'Thrusting' half of the bearing 'Outer race' and 'Rollers'.

Photo showing the 'Washboard' effect due to Electrical current Tracking.

The Root Cause Analysis of our problem was that the Gland seal Packing used on the Motor seals was Graphite based which is a good Electrical conductor and had created a 'By-pass' from the Earth straps and found its way through the shaft to the bearing in the Input shaft assembly.

We have now reverted back to the original type seals which are Non Conductive.

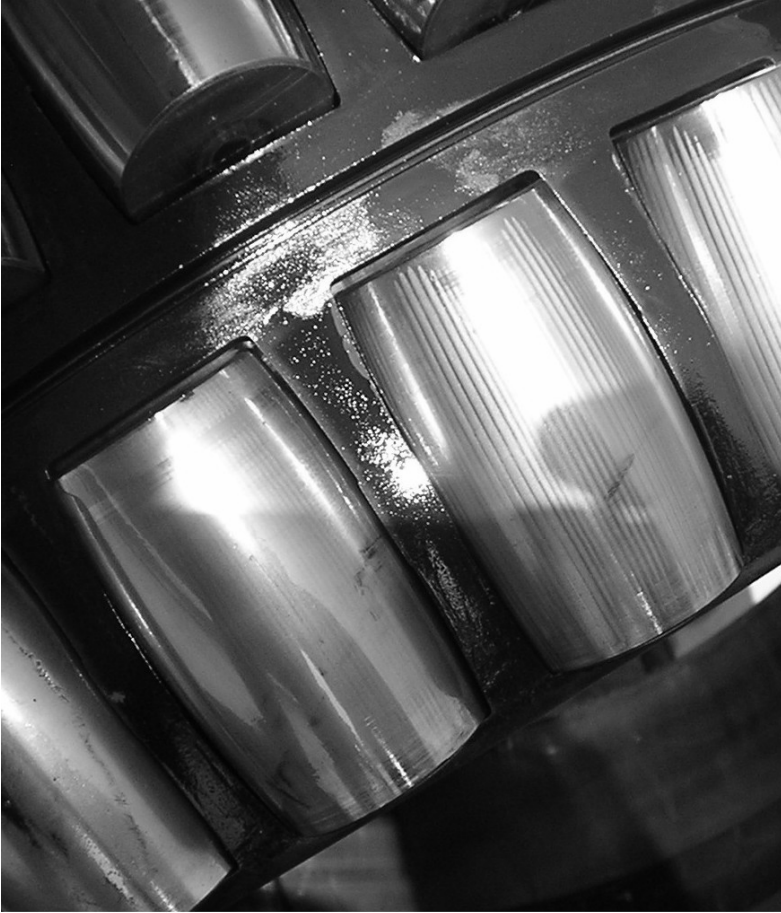
Photo showing the 'Washboard' effect on the Rollers (not all rollers).

New bearings were fitted at David Brown Engineering and 'set up' to manufacturers recommendations, this saved a lot of time at site and was just a matter of fitting straight into the pre-dowelled position.

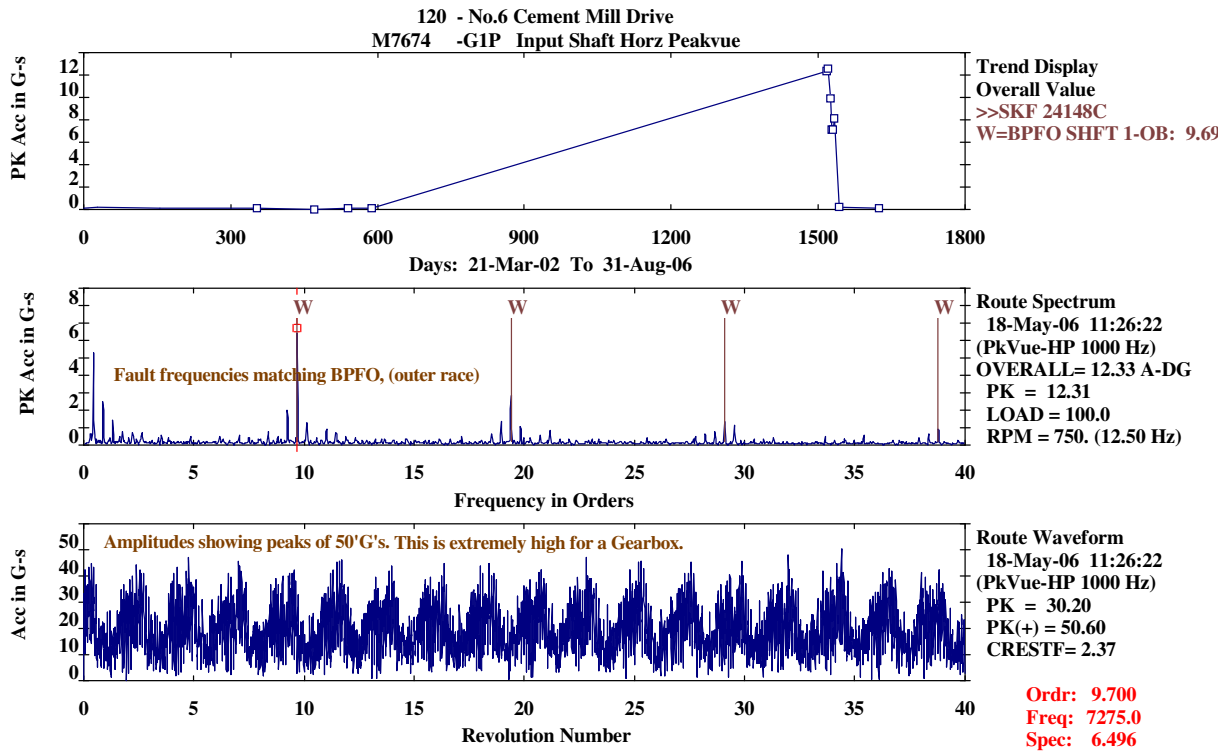
Readings taken above show severity of the bearing problem, very high impacting at BPFO and waveform severity readings of 50'G's. Readings this high could have been catastrophic if gone undetected.

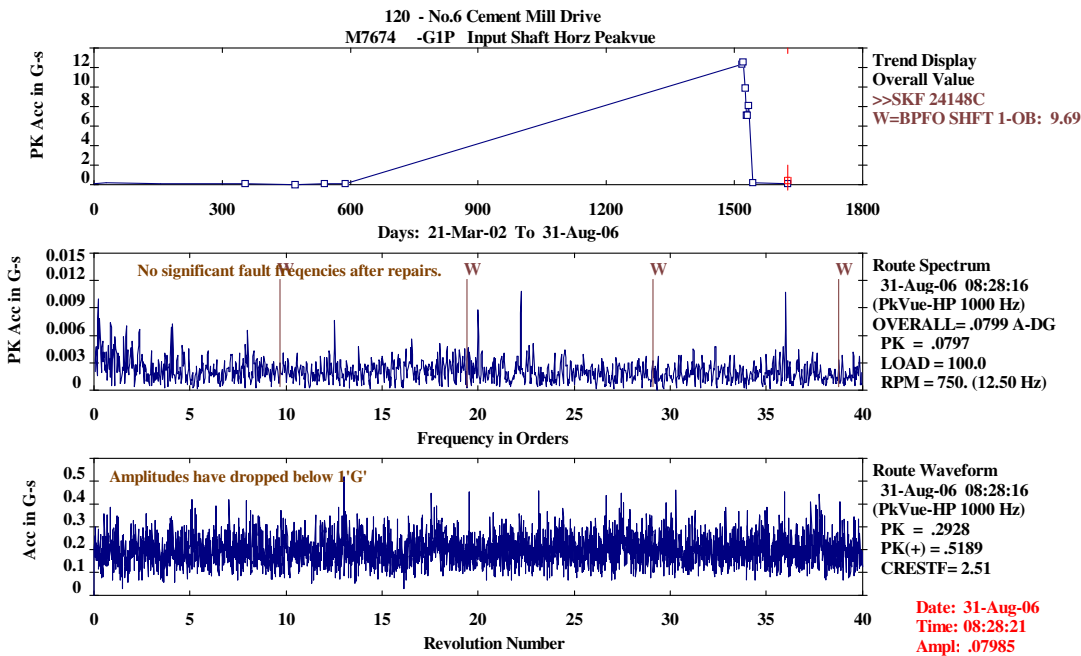
These readings shown are after repairs. The drop in amplitude of waveform severity to below 1 'G' and there are no significant peaks in the spectrum.

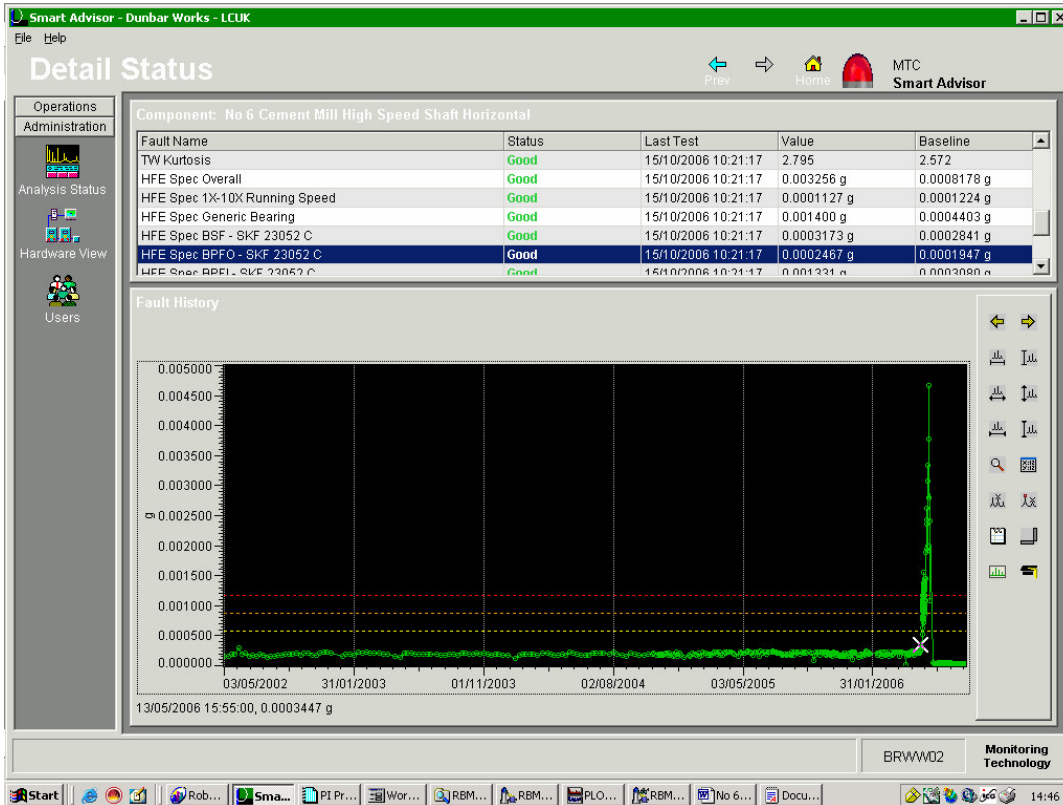
This is the readings from the MTC online system today.
